Keystone Academy Charter School  
4521 Longshore Avenue  
Philadelphia, Pennsylvania 19135

## Asbestos Inspection Report

NOVEMBER 10, 2020

**VERTEX Project No:** 65935

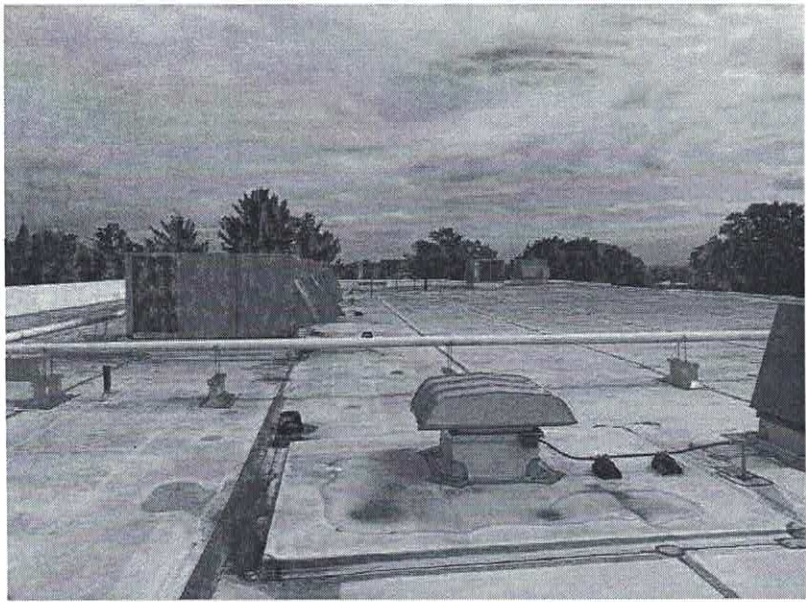
**Photograph: 3****Description:**

- No inspection/sampling was performed below finished grade or within confined spaces.
- The rubber membrane roof is not a suspect asbestos containing material and was not sampled as part of this investigation.

Rubber roof membrane

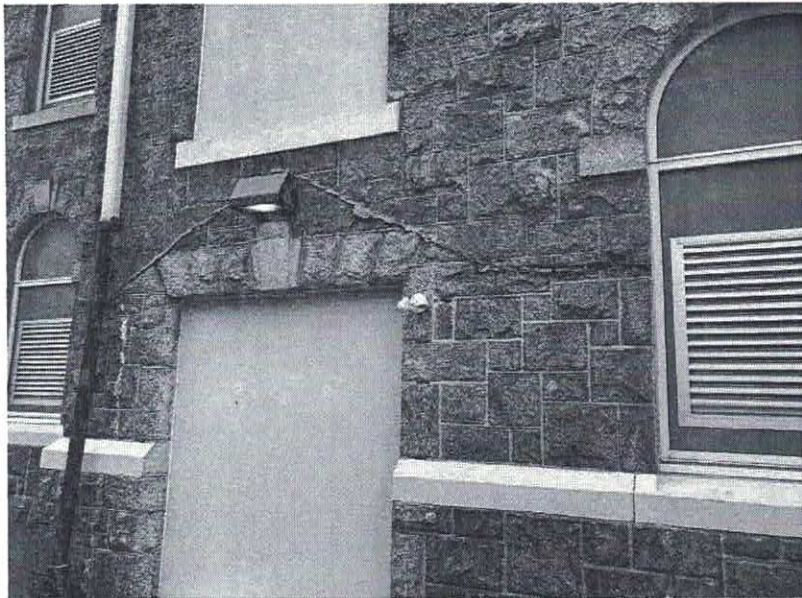
**Photograph: 4****Description:**

Location	Material Description	Estimated Quantity
Exterior stone façade adjacent to parking lot by basement steps	Remnant tar	10 LF

Remnant tar abated  
October 30, 2020

Note: The above material was abated by Plymouth Environmental Company, Inc. on October 30, 2020. VERTEX conducted air monitoring during the abatement. Our clearance letter is included attached to this report.

Specifically, VERTEX was retained to perform clearance air sampling after the removal of approximately 10 LF of remnant tar on stone façade on the exterior wall facing the parking lot of the abovementioned address. Final air testing was performed on October 30, 2020.

Analysis was performed via Phase Contrast Microscopy (PCM). Results of air tests yielded levels below 0.01 F/cc, the EPA recommended level for clean air.
